REPAIR REQUEST LIST

2165 Windmill Point Rd
11/14/2019 8:27 am

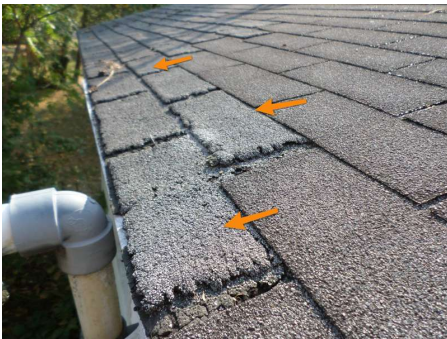
2.1.1 - Roof: Coverings

DAMAGED (GENERAL)

Roof coverings had visual damage in noted locations; not all areas may be shown. Recommend further evaluation and repair/replace fouled coverings.

Contact a qualified roofing professional.

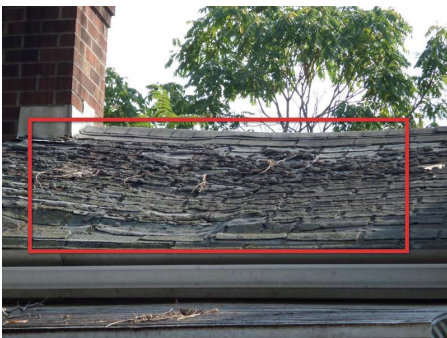
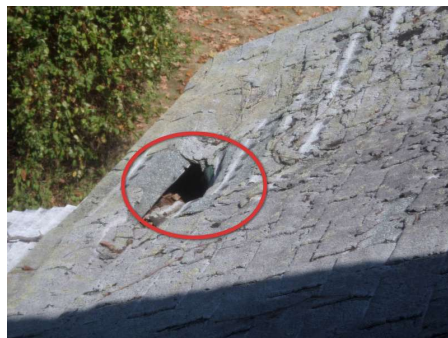
2.1.2 - Roof: Coverings

POSSIBLE LEAK POINT

The location noted is a possible cause of internal leaking. Inspector was not able to isolate the exact problem due to limitations. Recommend a roofing professional further evaluate and advise on repair.

Contact a qualified roofing professional.

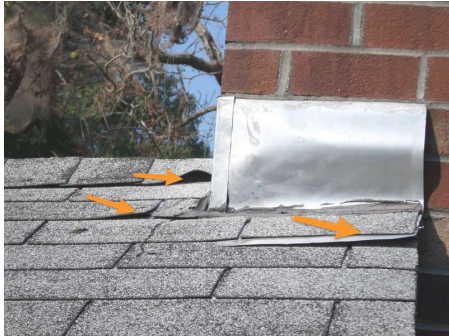
2.1.3 - Roof: Coverings

SHINGLE RAISED

One or more shingles were noted raised (likely due to nail pops) which could allow moisture intrusion and increase potential for wind damage over time. Recommend shingles are properly secured and monitored for any future problems.

Contact a qualified roofing professional.

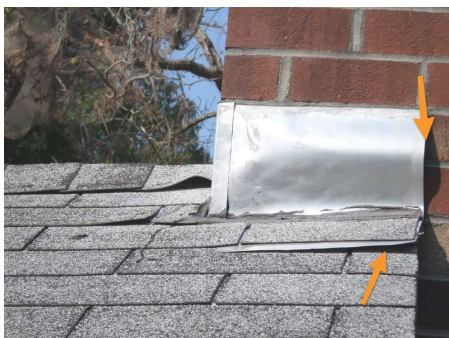
2.3.1 - Roof: Flashings

FLASHING LOOSE/SEPARATED

Flashing observed to be loose or separated, which can lead to water intrusion and/or moisture damage to underlying structure. Recommend replacing, repairing or refastening flashing.

Chimney

\$500 credit requested

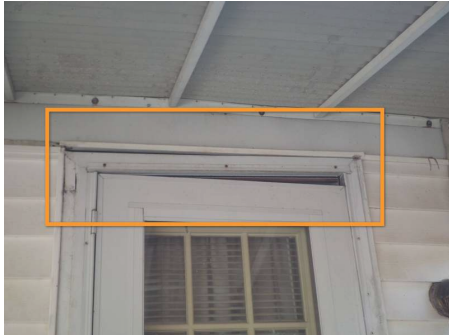
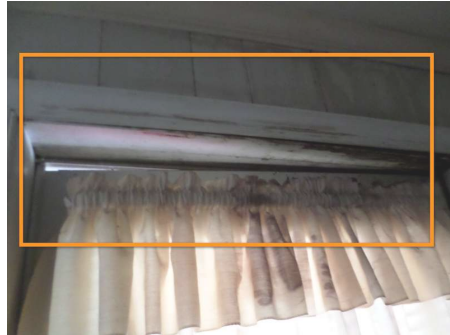
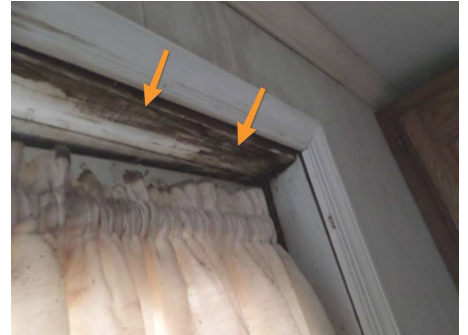
3.2.1 - Exterior: Exterior Doors

NEED REPLACING

One or more exterior doors were significantly damaged or deteriorated. Recommend that a qualified person replace door(s) as necessary.

Location
Kitchen

Recommendation
Contact a qualified door repair/installation contractor.

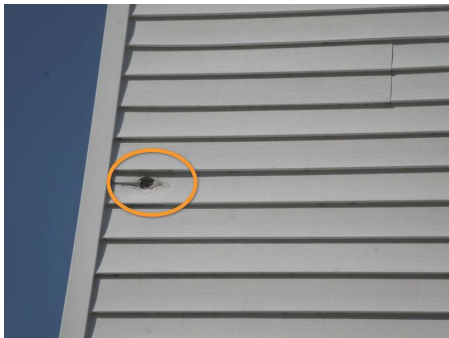
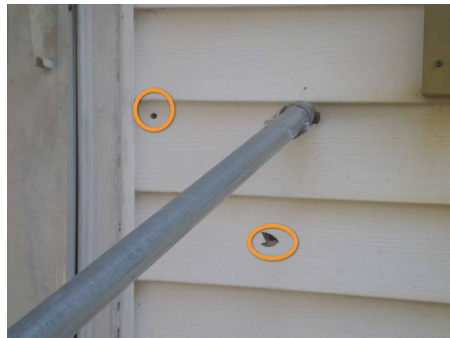
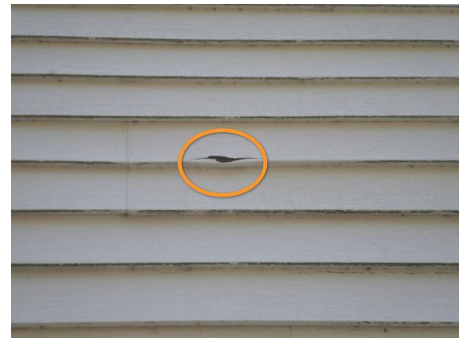
3.4.1 - Exterior: Siding, Flashing & Trim

SIDING DAMAGE

1 or more holes were noted at the time of the inspection in the siding.

Recommendation
Contact a qualified professional.

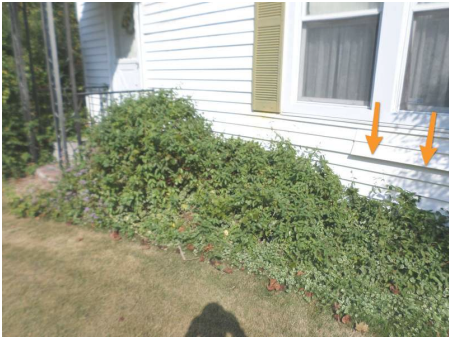
3.4.2 - Exterior: Siding, Flashing & Trim

SIDING LOOSE/GAPS

The siding had a gap and/or is loose in one or more that could allow for moisture penetration to the wall structure. Recommend either sliding panel to cover the gap or sealed.

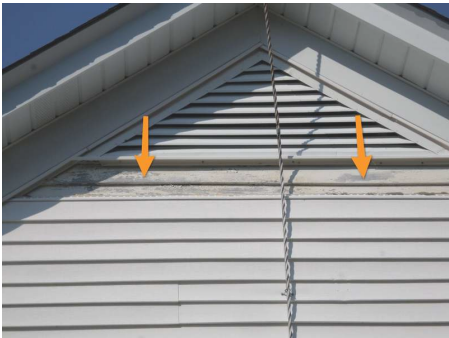
3.4.3 - Exterior: Siding, Flashing & Trim

SIDING MISSING

One or more areas of the siding was missing at the time of the inspection which could allow for moisture intrusion to supportive wall. Recommend correction by installation of approved siding.

Recommendation
Contact a qualified siding specialist.

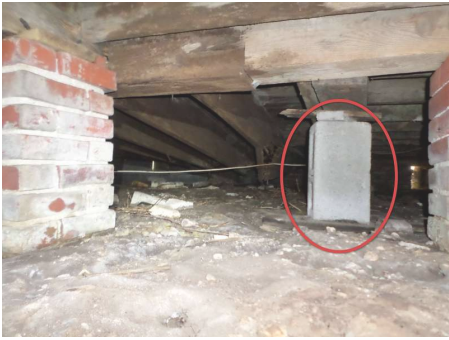
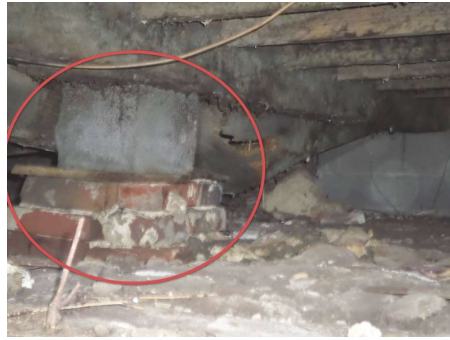
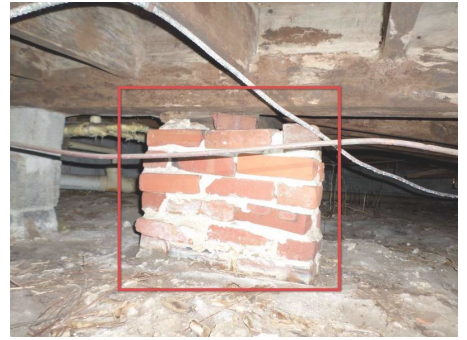
4.1.1 - Foundation & Structure: Foundation

COLUMNS DEGRADED

Safety Hazard/Immediate

1 or more columns or piers located in the crawl space was found to be degraded or improperly shored. Recommend evaluation and repair/replacement by a qualified professional.

Recommendation
Contact a qualified professional.

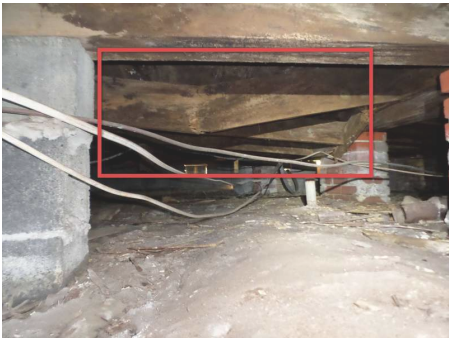
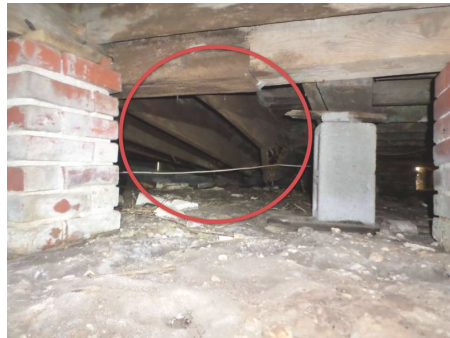
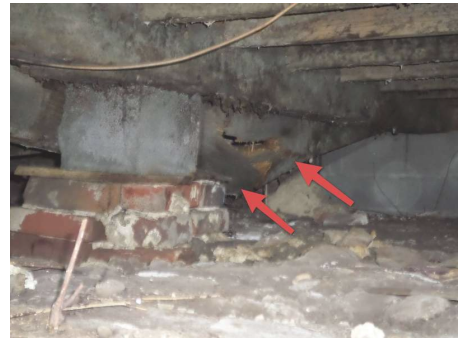
4.2.1 - Foundation & Structure: Floor Structure

JOISTS NEED REPAIR

**Safety Hazard/Immediate**

One or more floor joists were damaged or improperly installed. This can cause damage to the structural integrity of the home. Recommend a qualified structural engineer evaluate and advise on how to correct.

Location
Hallway and Living Room

Recommendation
Contact a qualified structural engineer.

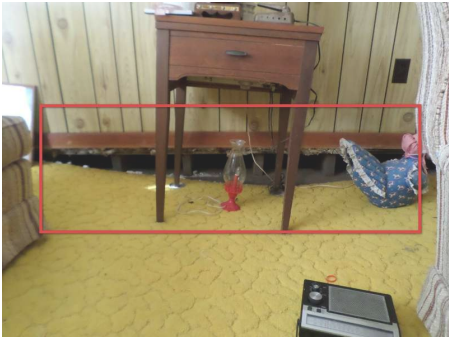
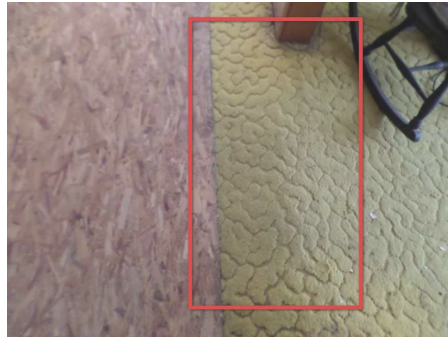
4.2.2 - Foundation & Structure: Floor Structure

UNEVEN FLOOR

**Safety Hazard/Immediate**

Uneven floors were noted in certain locations in the home, most notably in living room and hallway, likely caused by support column settling and shifting or damaged joists; not all areas may be shown. Recommend further evaluation and repair as needed.

Location
Hallway, Living Room, Upstairs Bedroom

Recommendation
Contact a qualified structural engineer.

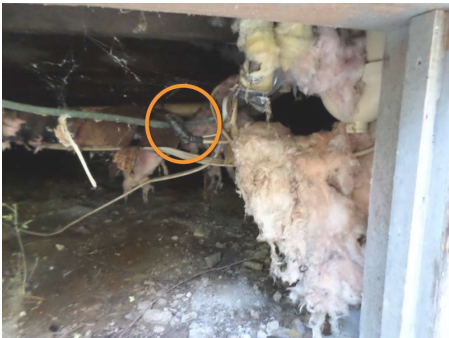
4.5.2 - Foundation & Structure: Crawlspaces

EXPOSED WIRING

Wires were found to be exposed and not properly capped or terminated in the crawlspace. Recommend repair/replace by a qualified professional.

Contact a qualified electrical contractor.

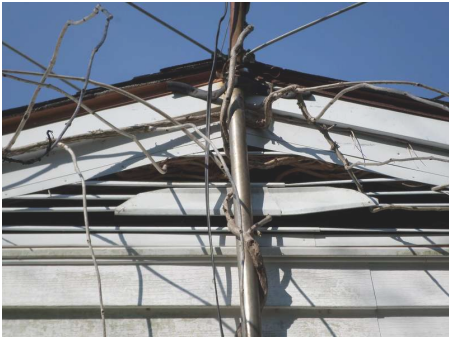
4.6.2 - Foundation & Structure: Attic Structure & Sheathing

GABLE VENT MESH DAMAGED

One or more of the gable vent protective screens/mesh is degraded and/or damaged which could allow pests access into attic as well as water damage. Recommend qualified professional repair/replace.

Contact a qualified professional.

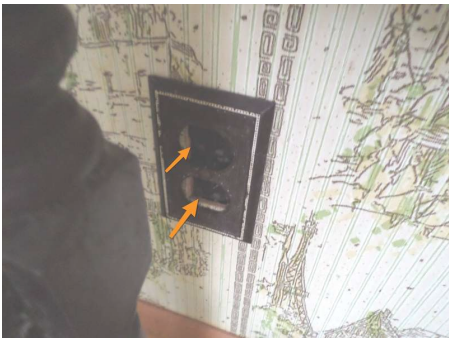
7.5.2 - Electrical: Outlets, Lighting, Switches, and Fans
(All Accessible)

RECEPTACLE COVER GAP

One or more receptacles had a gap in the cover which could allow objects to be inserted behind protective cover and produce a shock hazard. Recommend correction by a qualified professional.

Location
Downstairs Back Room

Recommendation
Contact a qualified electrical contractor.

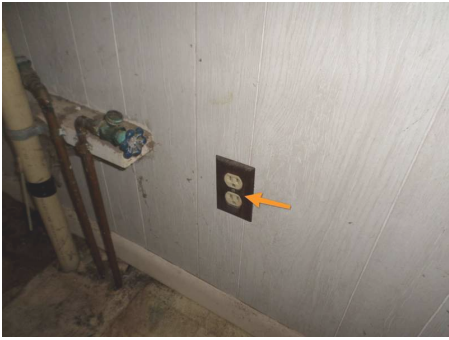
7.5.4 - Electrical: Outlets, Lighting, Switches, and Fans
(All Accessible)

RECEPTACLE NOT OPERABLE

Receptacles in noted locations did not operate when tested. Recommend qualified electrician evaluate and repair.

Location
Kitchen

Recommendation
Contact a qualified electrical contractor.

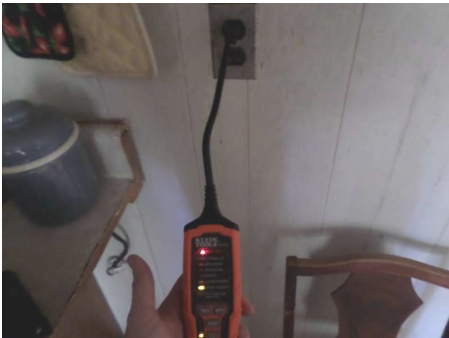
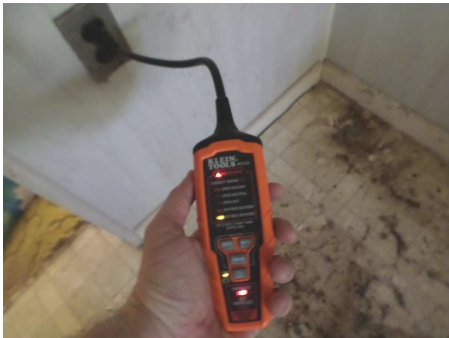
7.5.5 - Electrical: Outlets, Lighting, Switches, and Fans
(All Accessible)

REVERSE POLARITY

Safety Hazard/Immediate

Safety One or more receptacles have been wired with reverse polarity. This can create a shock hazard; GFCI not tripped when tested with disrupted device. Recommend correction by switching hot and neutral conductors on the receptacle.

Recommendation
Contact a qualified electrical contractor.

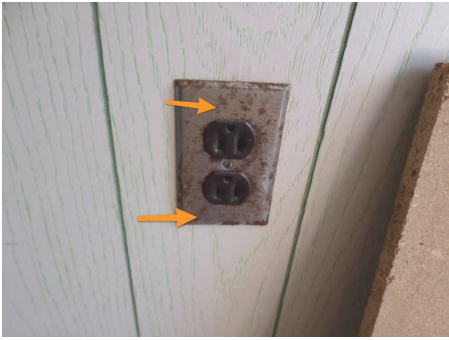
7.5.6 - Electrical: Outlets, Lighting, Switches, and Fans
(All Accessible)

RECEPTACLE COVER DAMAGED - EXTERIOR

Receptacle cover had rust at the time of inspection. Recommend repair/replace by a qualified professional.

Recommendation
Contact a qualified electrical contractor.

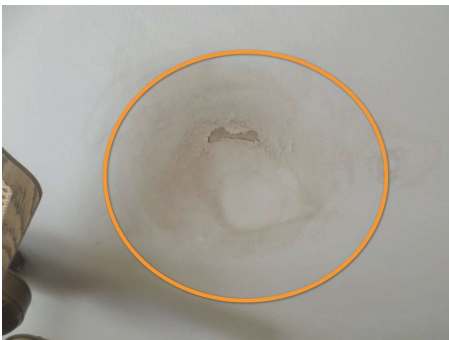
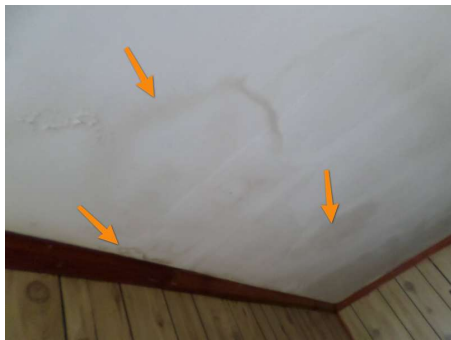
8.4.1 - Interior, Doors and Windows: Walls, Ceilings and
Fixtures

CEILING - DRY STAINS, MONITOR

Stains were found in one or more ceiling areas. The stain(s) may be due to past roof and/or plumbing leaks. Consult with the property owner and monitor the stained area(s) in the future, especially after heavy or prolonged rain. If elevated moisture is found in the future, then recommend that a qualified contractor evaluate and repair as necessary.

Various Rooms

Contact a qualified professional.

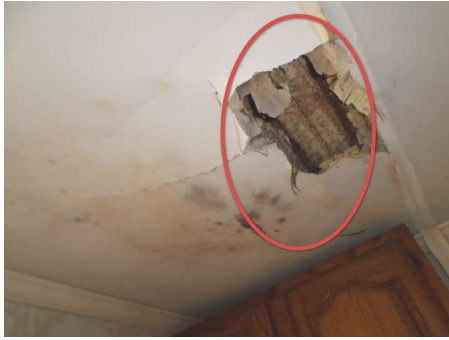
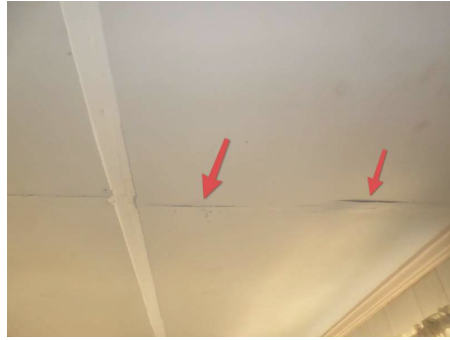
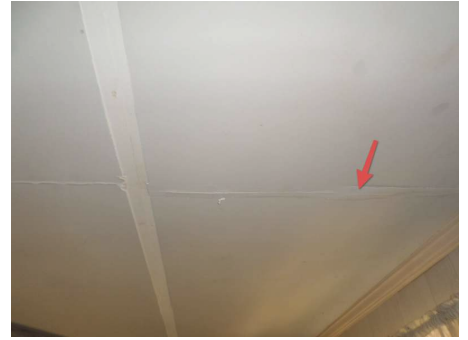
8.4.2 - Interior, Doors and Windows: Walls, Ceilings and
Fixtures

MAJOR CRACKS, DOOR JAMBS NOT SQUARE, MANY DOORS BIND

Safety Hazard/Immediate

This structure appears to have settled, or was leaning significantly based on the presence of cracks in walls, ceilings or junctions between them, or numerous door frames not being square, or numerous doors binding in jambs. Recommend that a qualified contractor and/or engineer evaluate further. Significant repairs may be needed. If so, a qualified contractor should make repairs.

Contact a qualified general contractor.

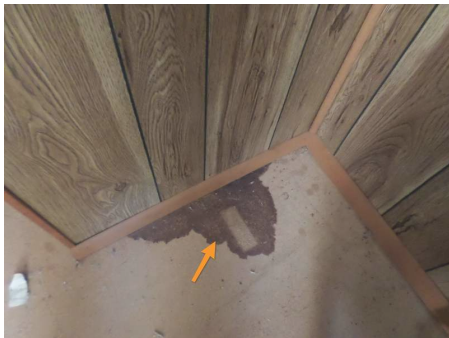
8.5.3 - Interior, Doors and Windows: Floors

WATER STAIN

Water stains were found in one or more rooms. It is recommended that a qualified professional evaluate the area for leaks and recommend repair/replace the affected area(s).

Contact a qualified professional.

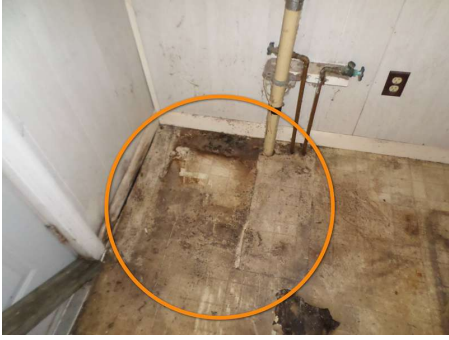
10.4.1 - Kitchen: Floors

WATER DAMAGE

Flooring in the kitchen appeared to have been damaged by water. Recommend repair/replace by a qualified professional.

Kitchen

\$1000 credit requested

Contact a qualified professional.
